CRITICAL AREAS REPORT

Al Helenberg Memorial Boat Launch Maintenance Dredging *Castle Rock, Washington*

Prepared for
City of Castle Rock
P. O. Box 370
Castle Rock, Washington 98611
(360) 274-7478

Prepared by
Ecological Land Services
1157 3rd Avenue, Suite 220A • Longview, WA 98632
(360) 578-1371 • Project Number 102.89

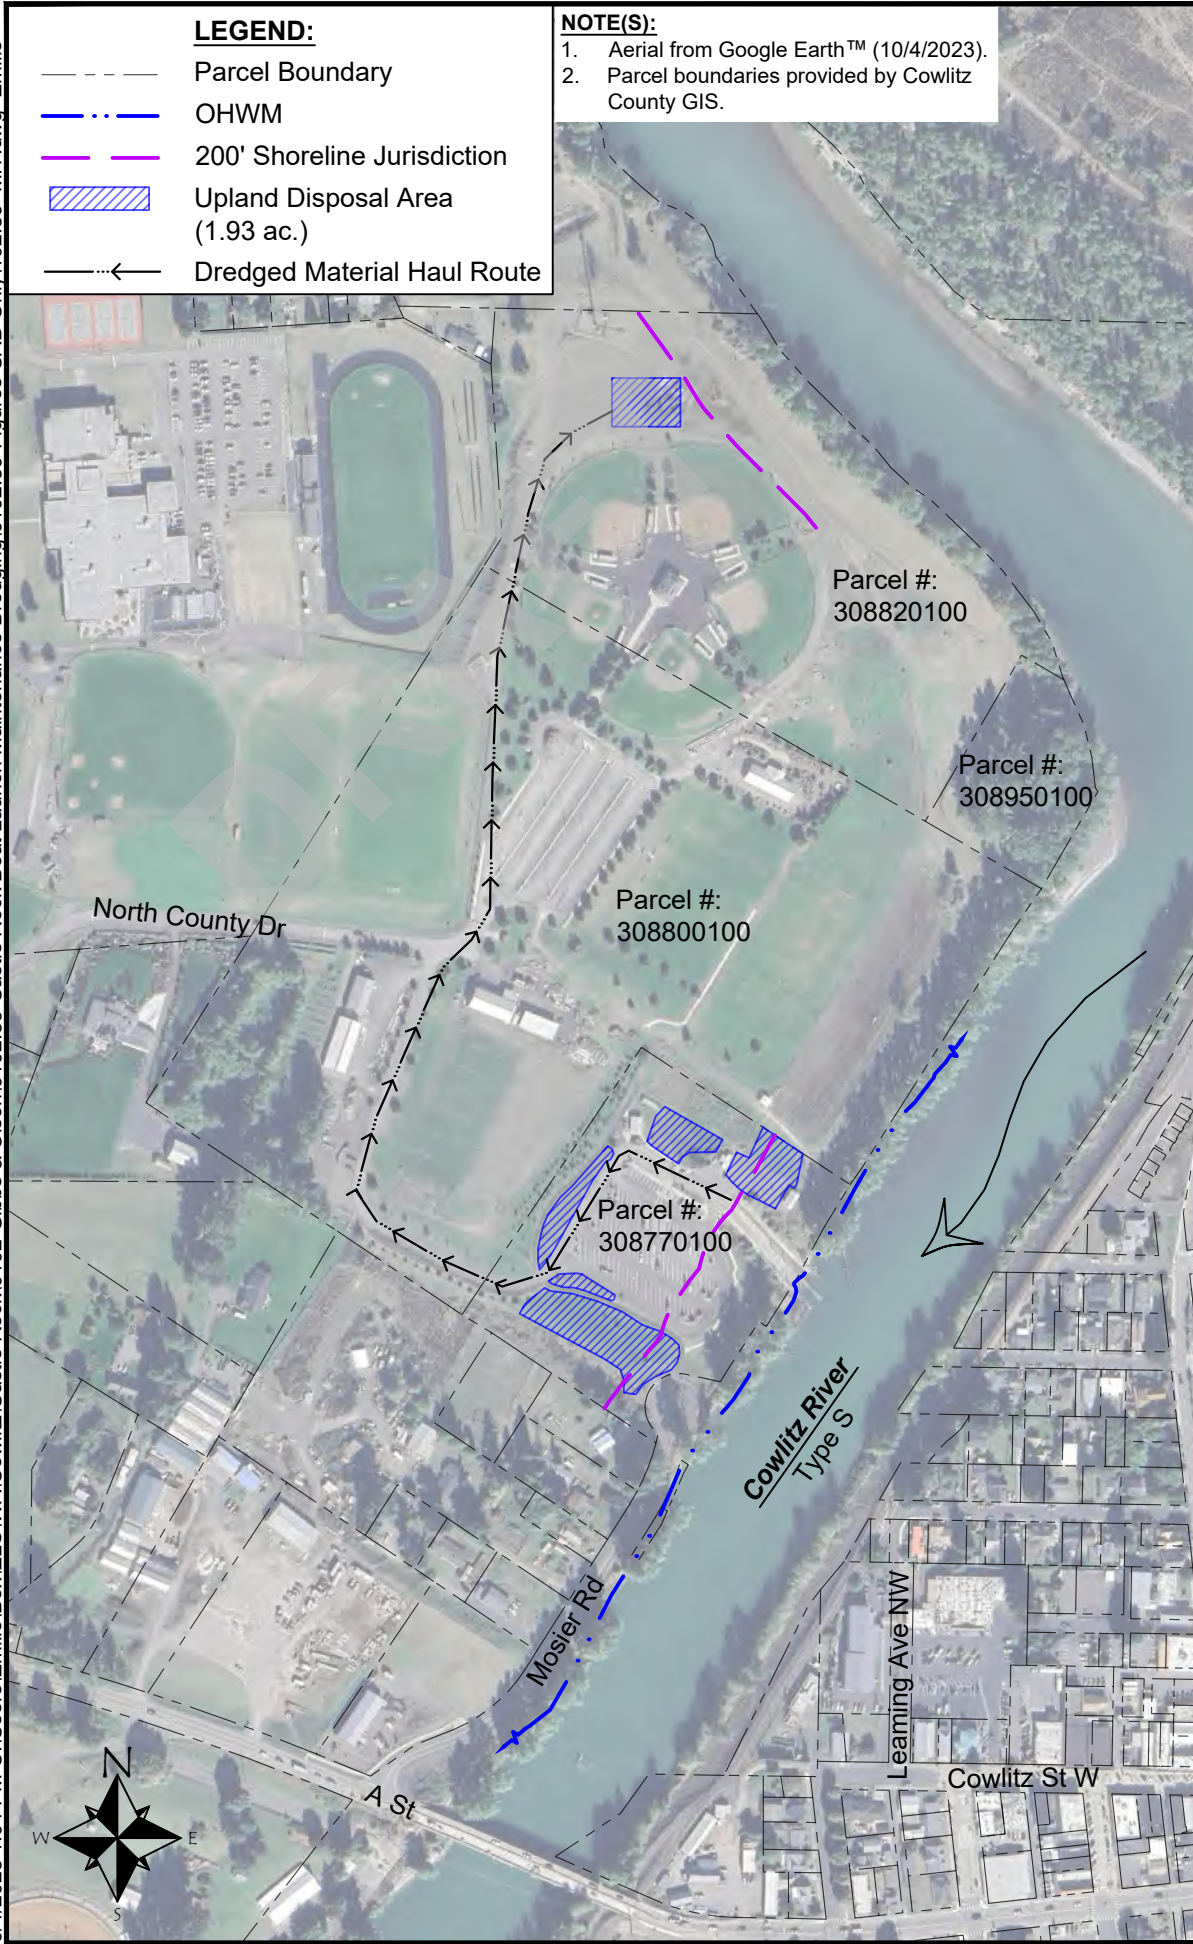
- Parcel Boundary
- OHWM
- 200' Shoreline Jurisdiction
- Upland Disposal Area (1.93 ac.)
- Dredged Material Haul Route

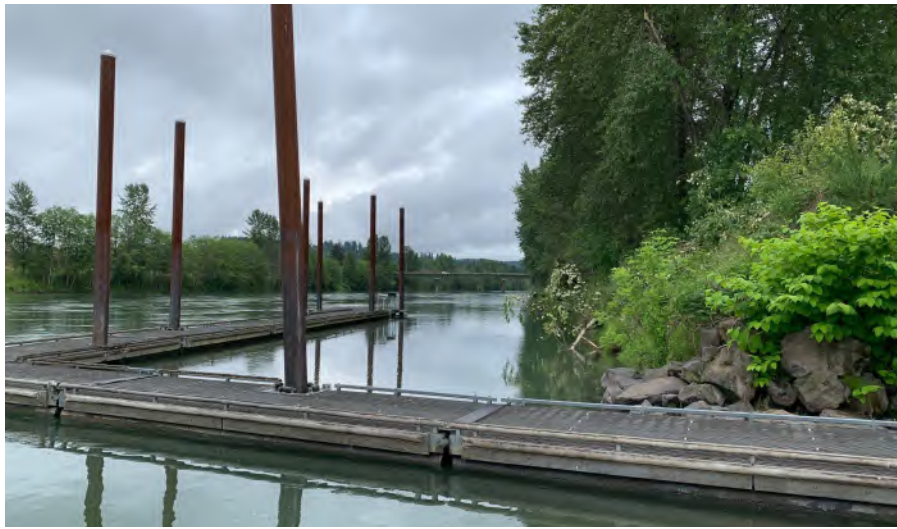
Photo 1. Taken June 2020. Dock at boat launch on the Cowlitz River facing downstream.

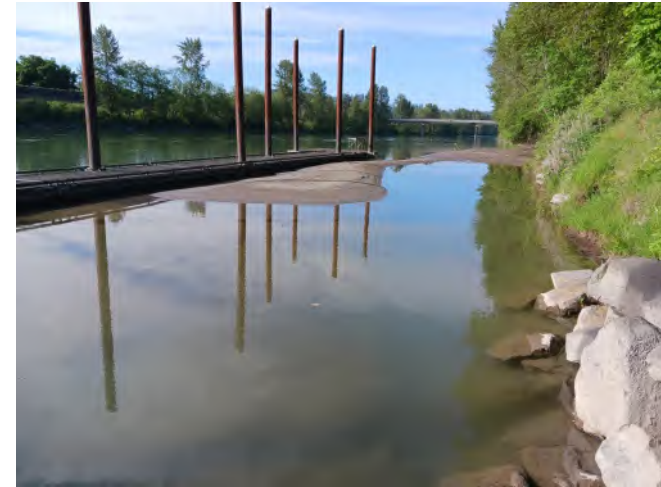
Photo 2. Taken June 2025. Looking downstream at dock shown in Photo 1. Both photos were taken at similar river levels. Photo 2 shows significant sediment accumulation.

The estimated volume of material to be removed initially is approximately 500 cubic yards. During a site visit on June 2, 2025, it was noted that a significant sediment build-up has occurred between the dock and the shoreline, as shown on the photoplate. It compares a photograph taken in June 2020 with photographs taken on June 2, 2025.

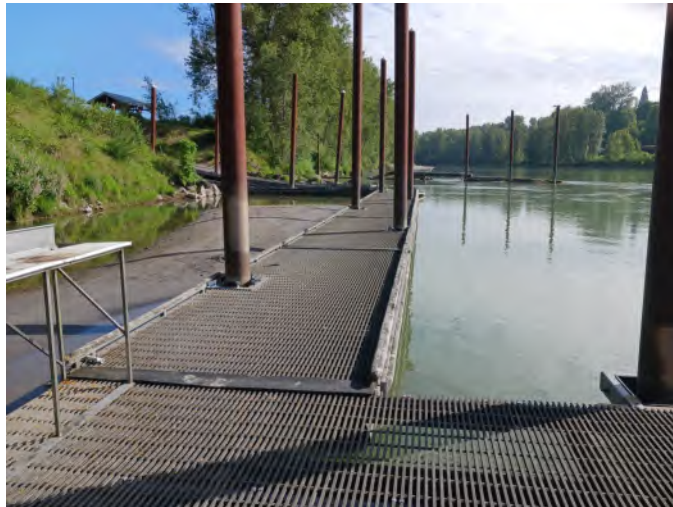
Photo 3. Taken June 2025 from end of dock looking upstream at ramp and log boom.

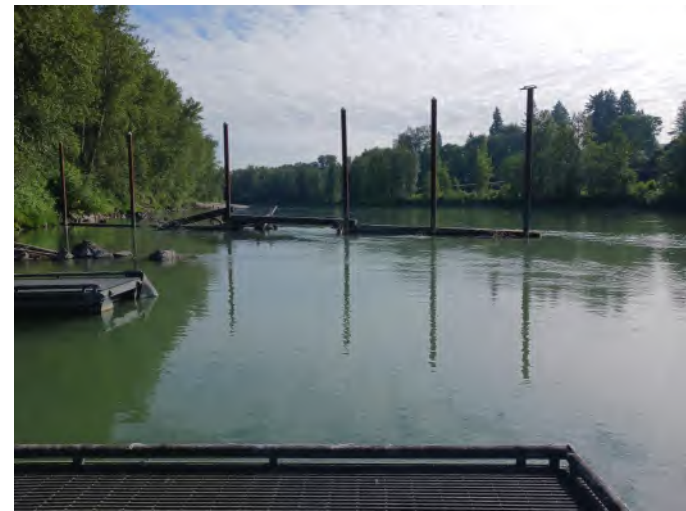
Photo 4. Looking upstream at log boom. Photo taken June 2025.

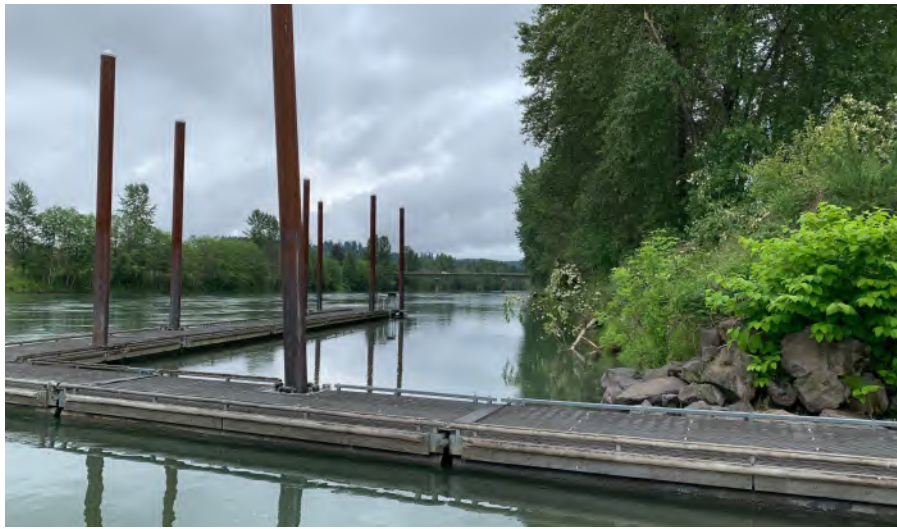
Photo 1. Taken June 2020. Dock at boat launch on the Cowlitz River facing downstream.

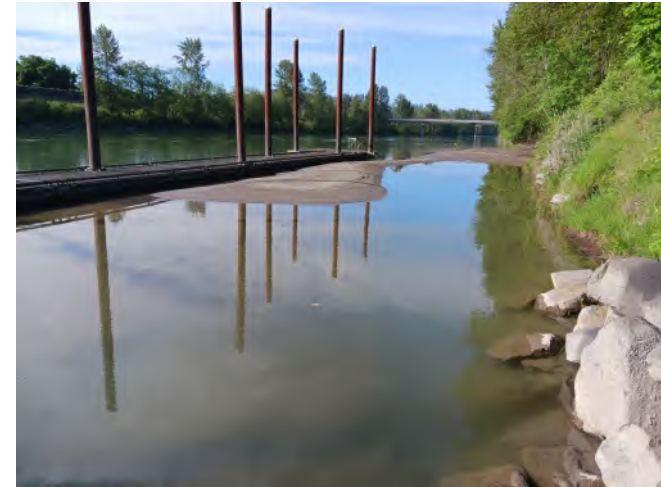
Photo 2. Taken June 2025. Looking downstream at dock shown in Photo 1. Both photos were taken at similar river levels. Photo 2 shows significant sediment accumulation.

The estimated volume of material to be removed initially is approximately 500 cubic yards. During a site visit on June 2, 2025, it was noted that a significant sediment build-up has occurred between

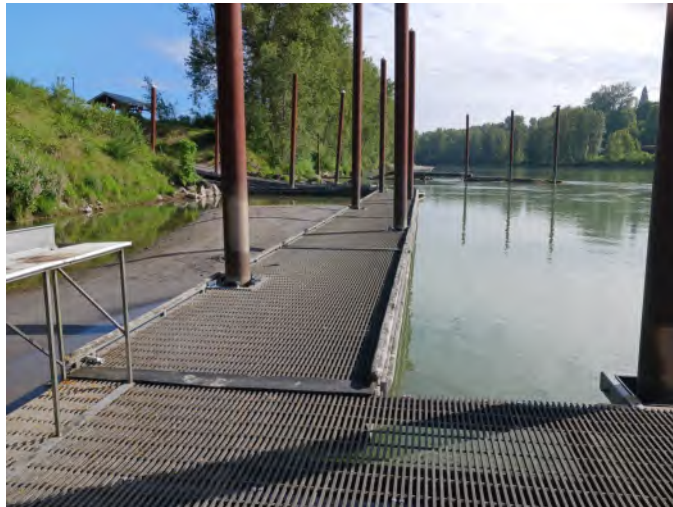
Photo 3. Taken June 2025 from end of dock looking upstream at ramp and log boom.

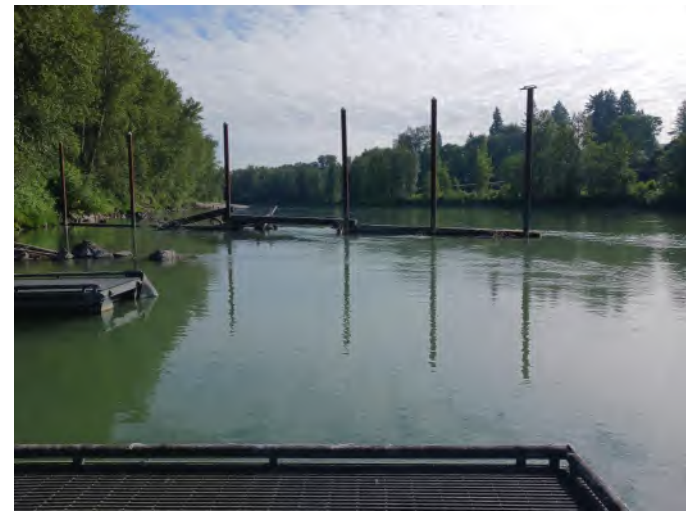
Photo 4. Looking upstream at log boom. Photo taken June 2025.
